BUREAU OF SHIPS
TECHNICAL INSPECTION REPORT.

OPERATION CROSSROADS.
U.S.S. FALLON (APA 81).

TEST BAKER.

VOLUME 2 [U].

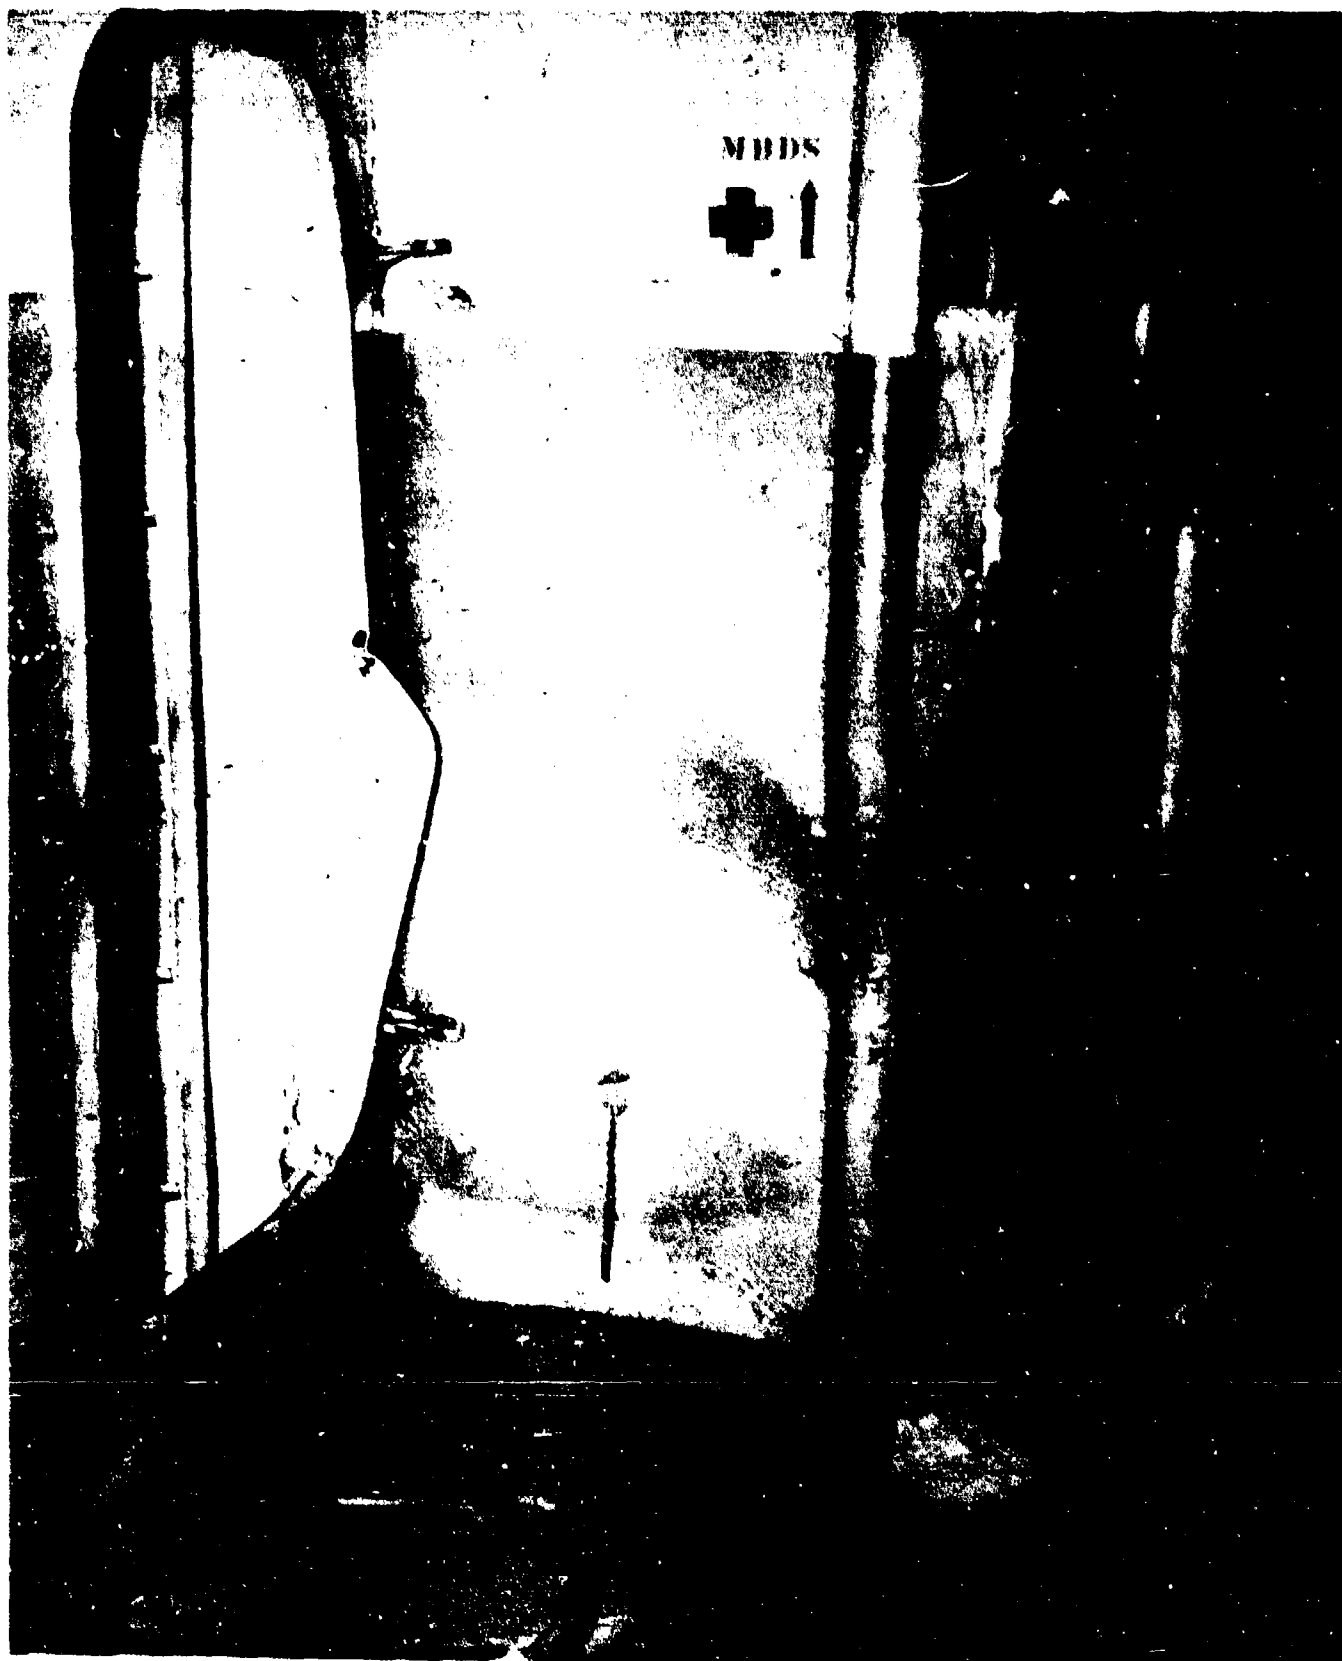
AB-CR-68-1789-6. Damaged door and bulkhead at escape trunk B-205-3MT frame 92, port side of main deck, looking aft from frame 89. Note door lying on deck.

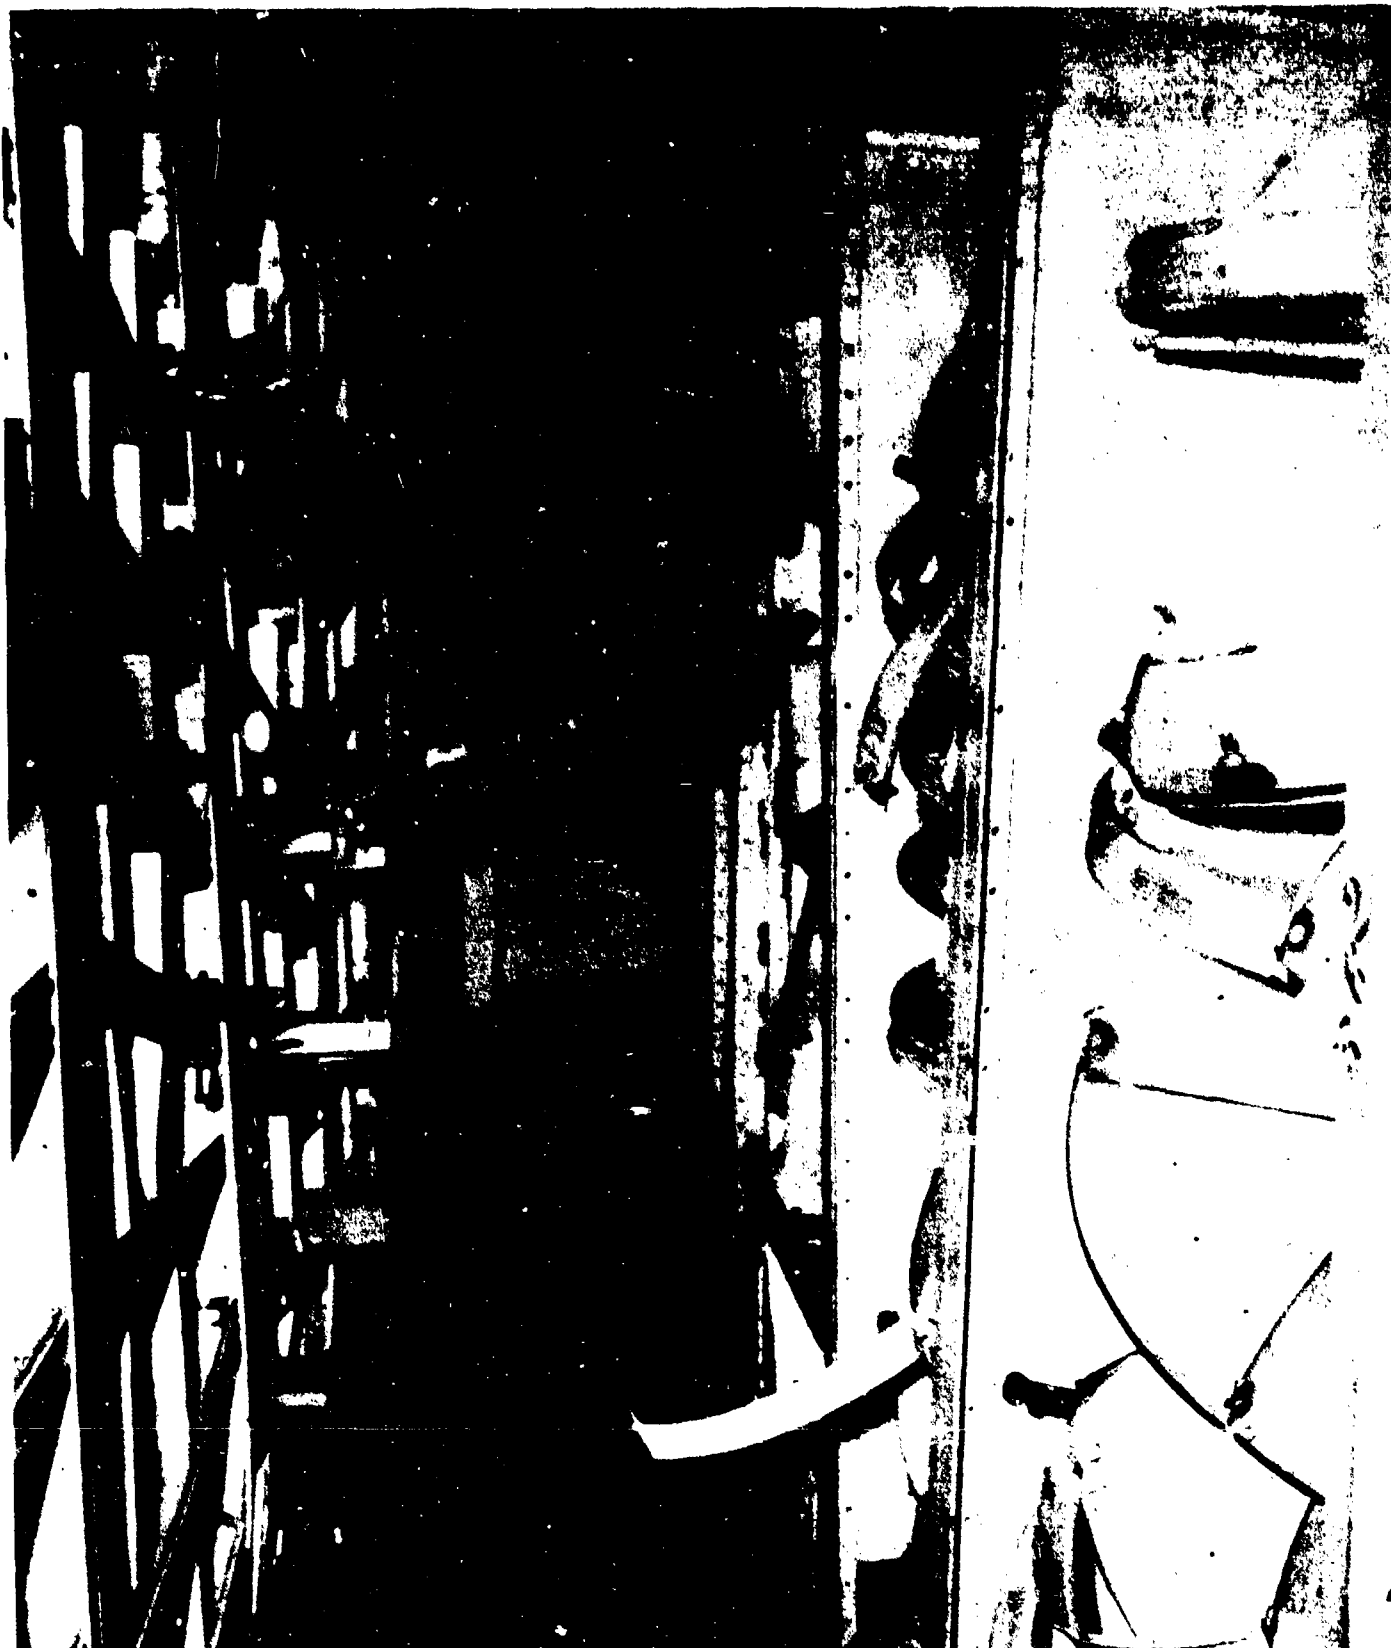
AB-CR-76-2527-5. S.D. stores, second platform looking to port from access at frame 32, centerline.

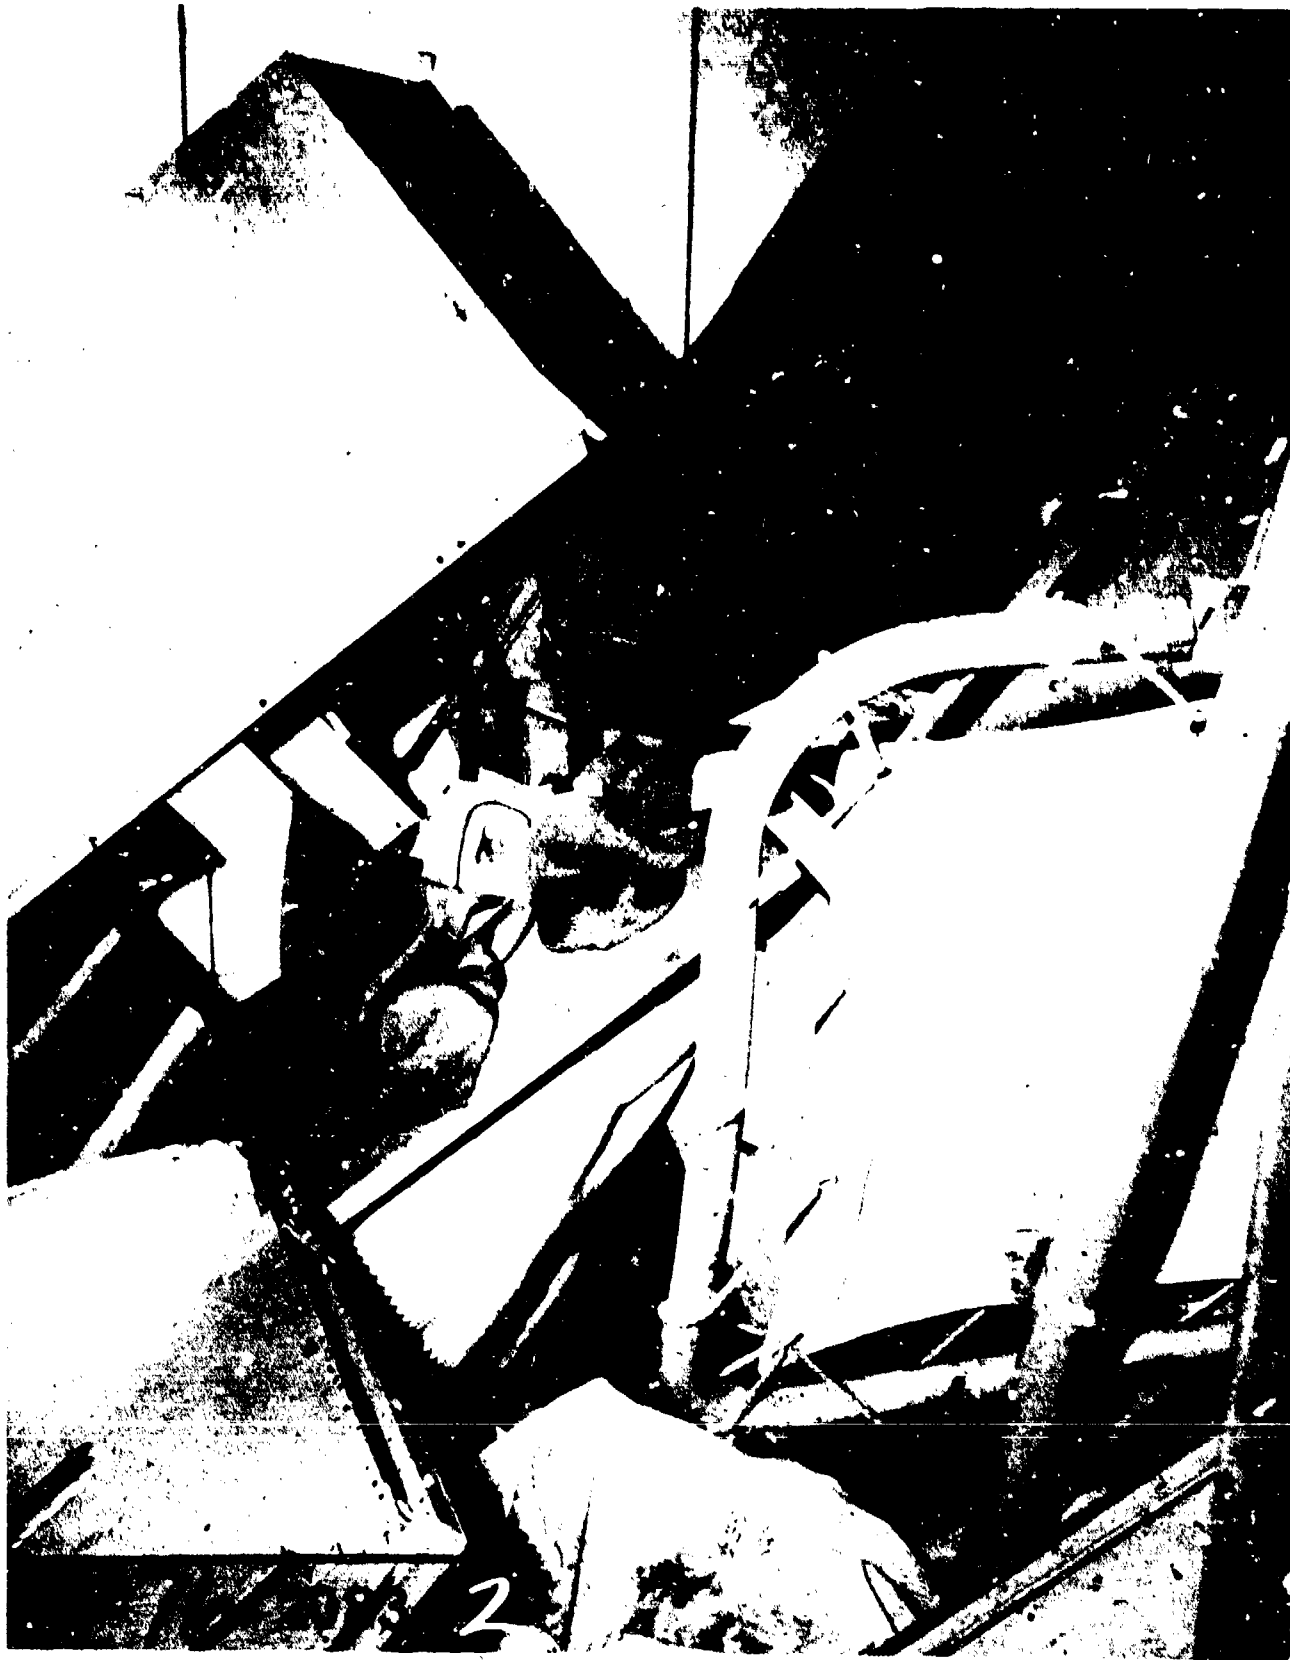
AB-CR-76-2083-2. General disorder in crews berthing space on main deck port side abreast No. 2 hatch.

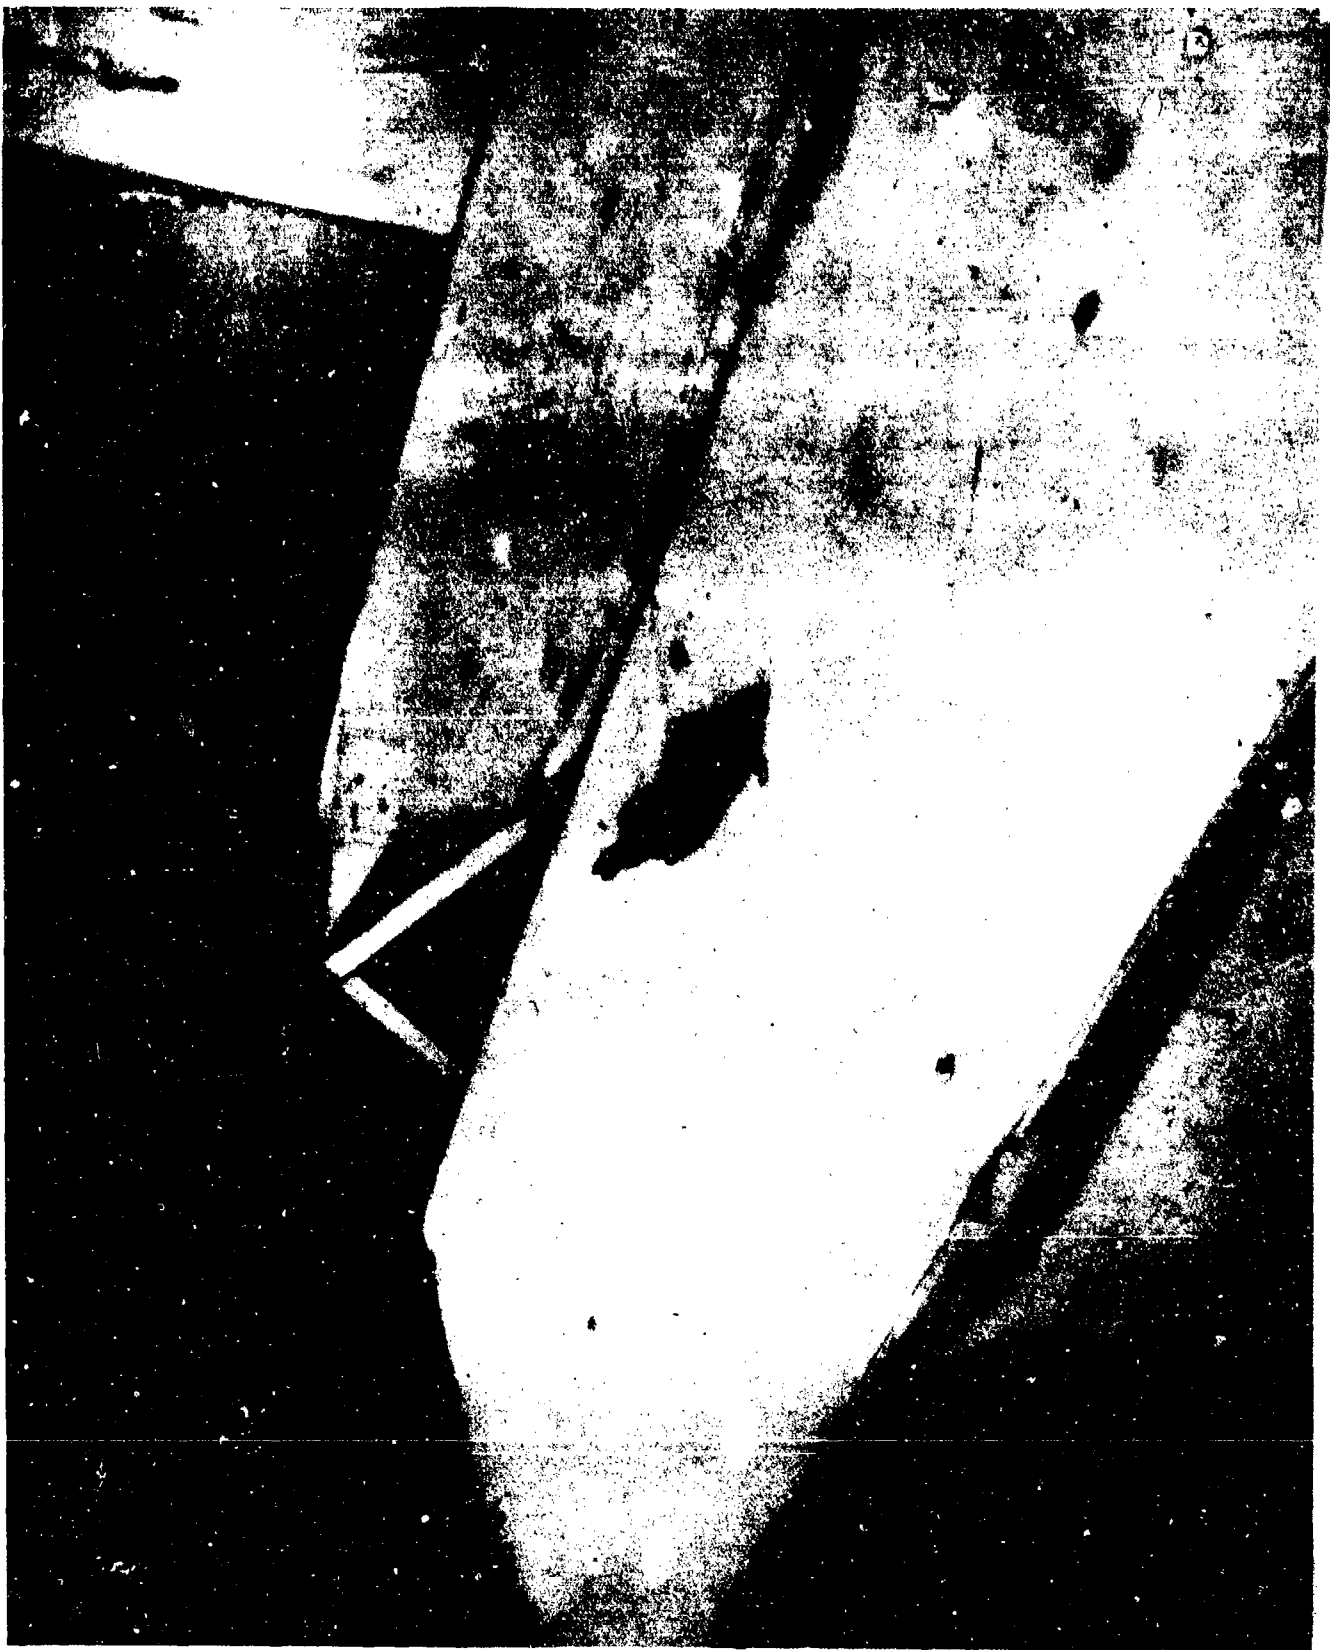
AB-CR-76-2083-1. Fragment in fallen locker under No. 2 hatch, main deck starboard.

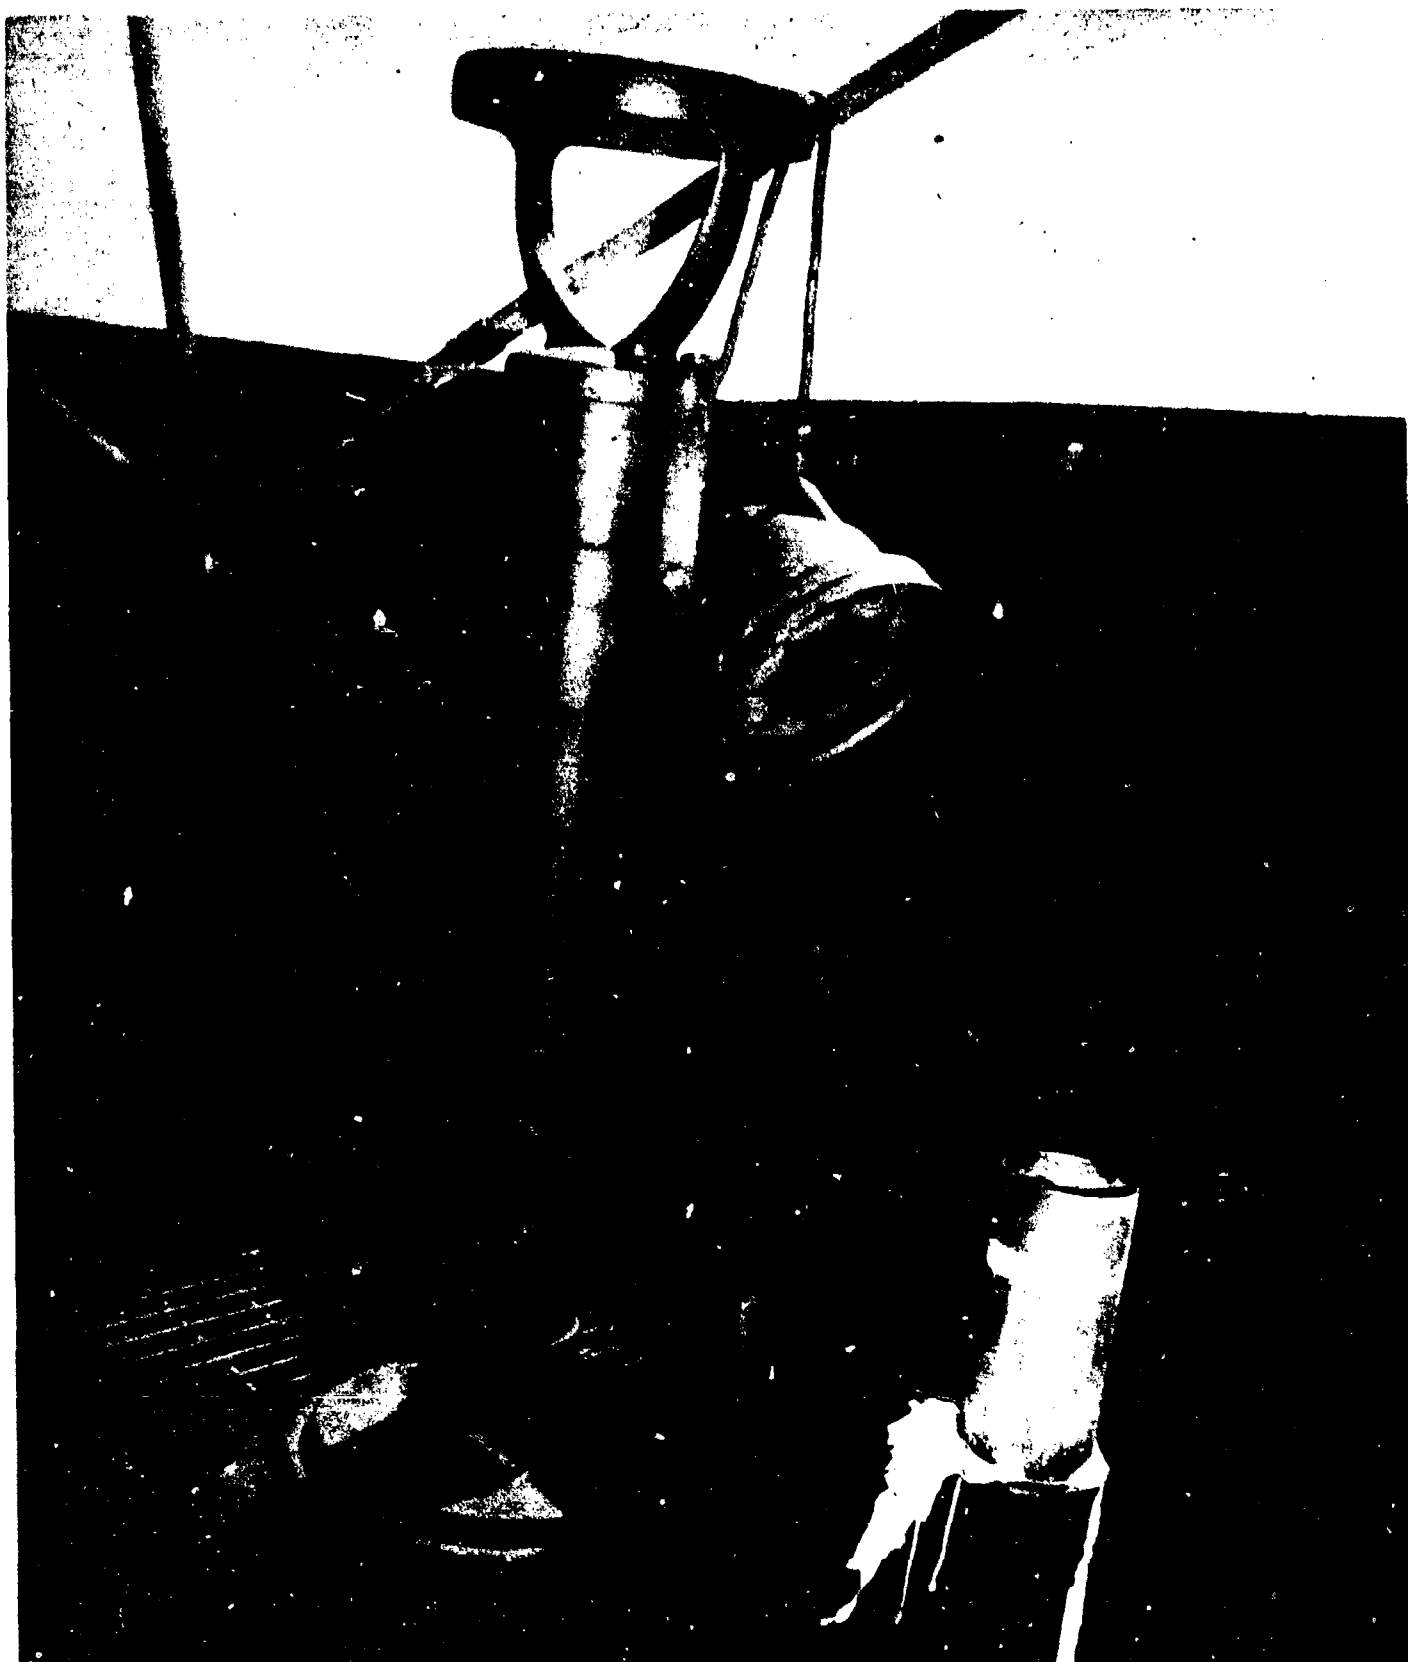
AB-CR-100-1791-2. Port pelorus navigation bridge. Showing binnacle ring and repeated detached from pelorus stand.

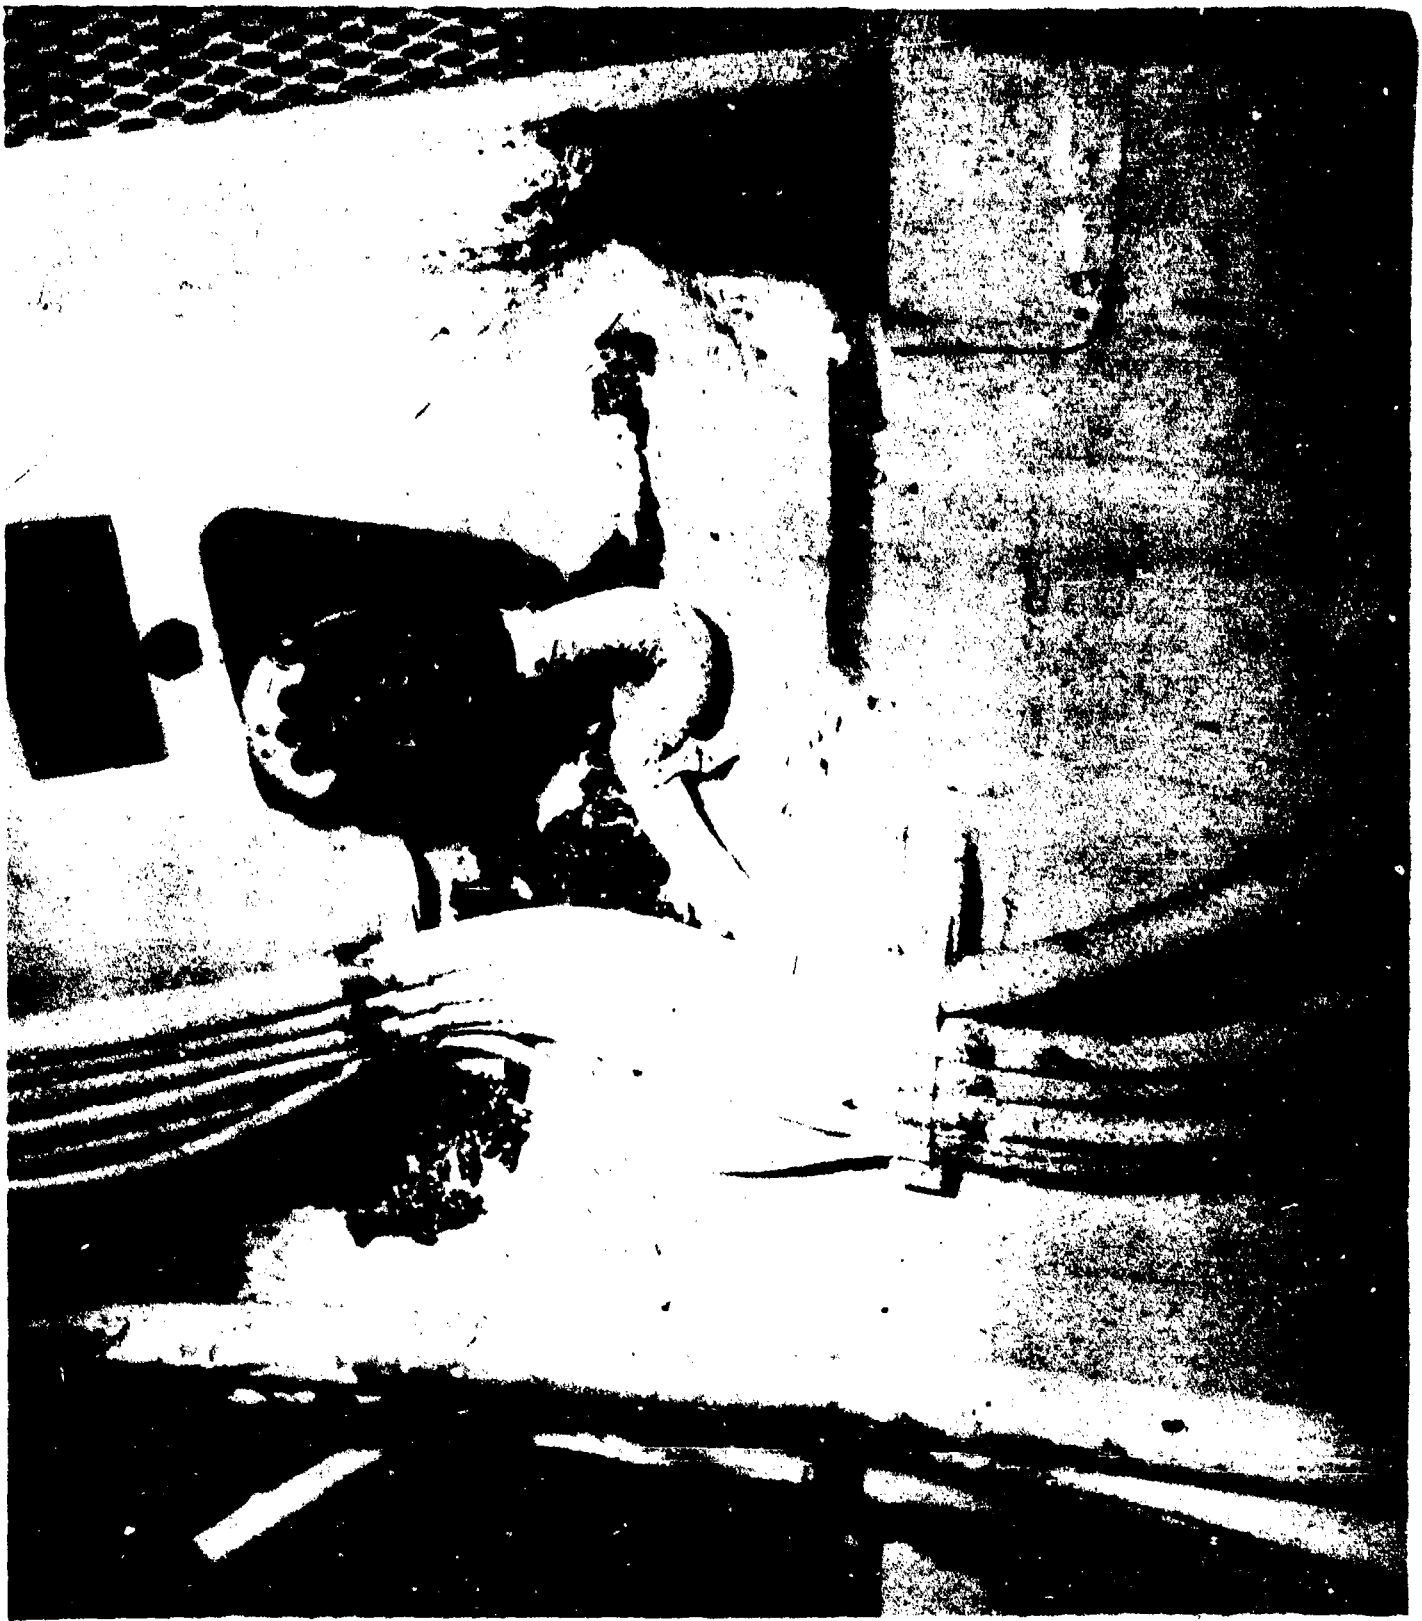
AB-CR-100-1791-6. View showing vertical cable run intact on distorted bulkhead. Frame 83 port side.
